# **LOUISIANA DEPARTMENT OF WILDLIFE & FISHERIES**

**WATERBODY MANAGEMENT PLAN SERIES**

**SALINE LAKE**

**LAKE HISTORY & MANAGEMENT ISSUES**

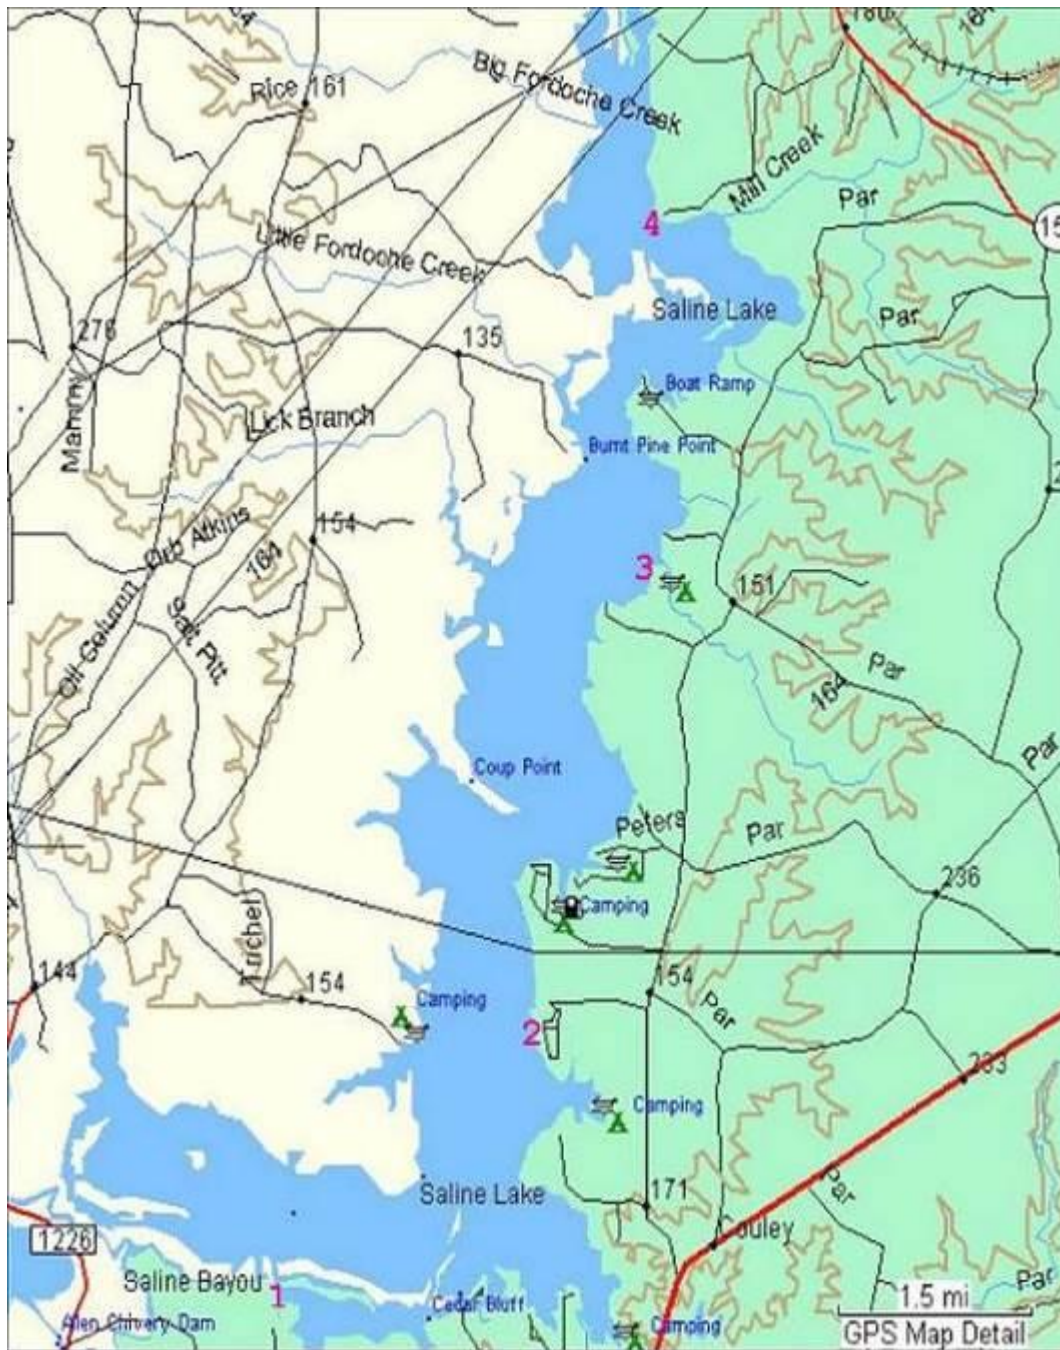
### SALINE LAKE BOAT RAMP LOCATIONS

#1 Spillway Ramp  
#2 Mulligan Inn

#3 Keyhole  
#4 Sandpoint
